Report: 001521BergHolcomb421NE87th **Address:**

Confidential Inspection Report

September 3, 2014

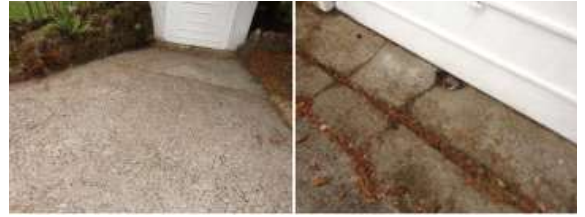
Steep driveway has moderate deterioration. Suggest installing trench drain at bottom to prevent draining into garage.

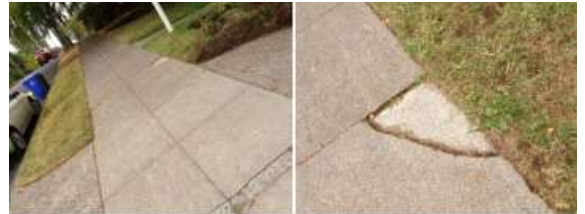
Minor damage is noted. Suggest repairs.

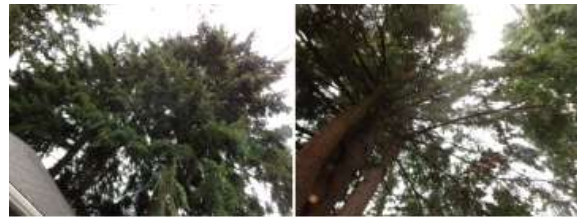
Trim tree branches away from building and roof. Monitor and maintain trees properly trimmed to prevent hazardous conditions. Maintain at least one to two feet of clearance between building and plants.

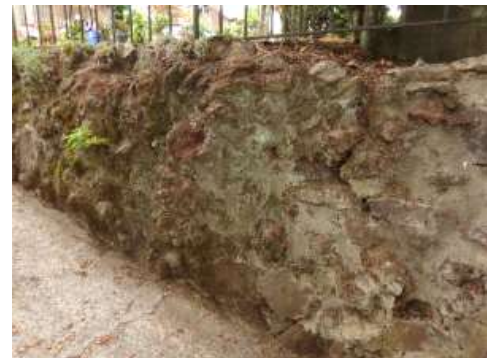
Appears serviceable. Minor cracking and deterioration is noted.

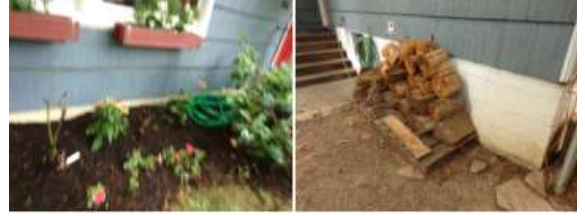
Gentle slope.
 Maintain proper clearance of six inches below any wood materials. Siding/trim etc. as well as below sills of crawlspace vents or basement windows.
 Do not store wood near foundation. Minor corrections at grade are recommended.

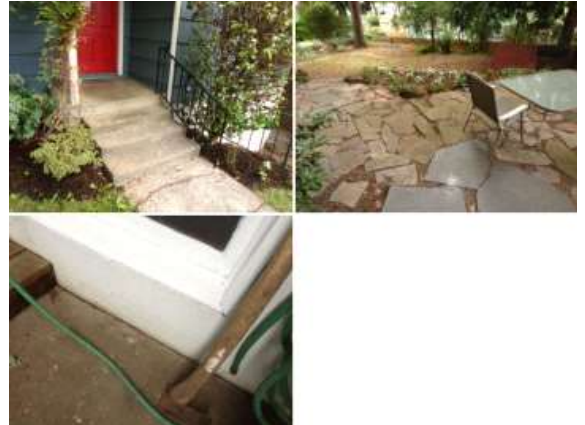
Stone pavers.
 Front porch is concrete.
 Appears serviceable.
 Porch is in serviceable condition.
 Recommend sealing all cracks and gaps between concrete sidewalk, patios and foundation.

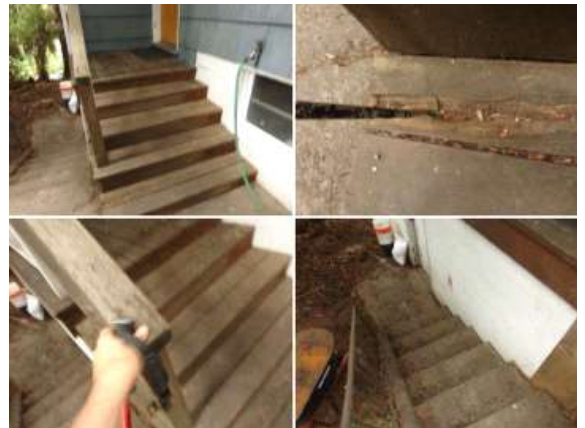
Rear stairs are deteriorating. Railing is loose. Improvements are recommended to prevent conducive conditions.
 Recommend sealing between stairs and foundation.

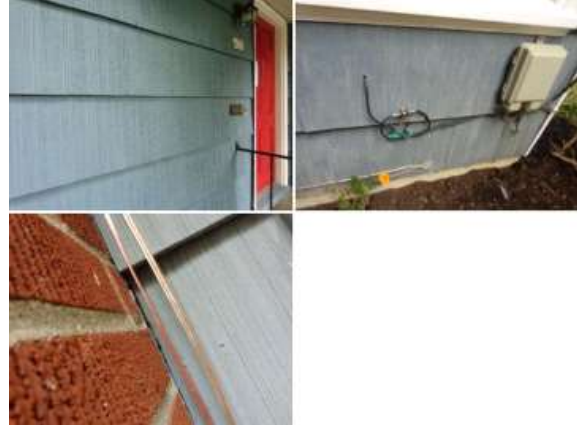
Appears serviceable south side is in need of paint. Make corrections in the near future
 Maintain all caulking between trim and siding in good condition. Caulk between siding and chimney.
 Siding will need to be painted every 5 to 8 years. Caulking needs to be checked annually for damage. Complete any repairs as needed.
 Insure caulking is in good condition between chimney and walls as well as between any siding and trim.

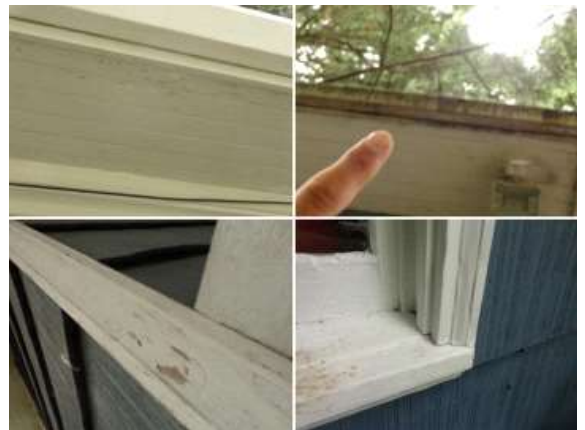
Paint deterioration is noted in several areas. Priming/painting and caulking are needed. to prevent further damage. Fascia under gutters on west side of building appear to have some rot. Corrections are needed.
 A) Ensure all gutters are properly draining. B) Paint any areas needed and repair all damaged.
 Peeling paint is noted under eaves.
 Maintain Trim in well painted and caulked condition. (Check all doors and windows for

damaged (caulking)
Ensure annual
inspections are
conducted and touch up,
caulking and repairs are
completed as needed.

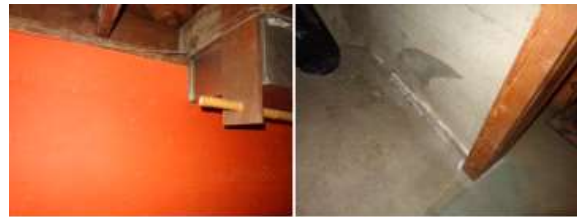
Foundation is
serviceable. Minor
efflorescence is noted.
(Normal)

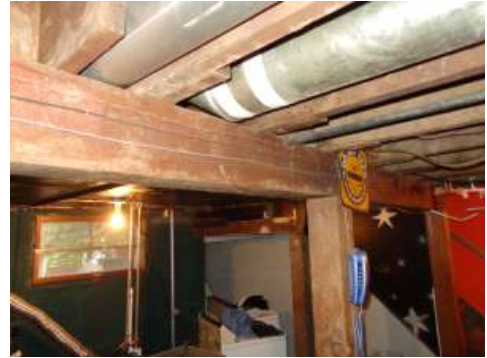
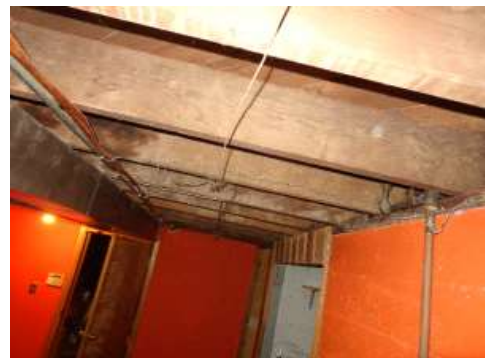
Appear serviceable
Typical Cracks are noted.

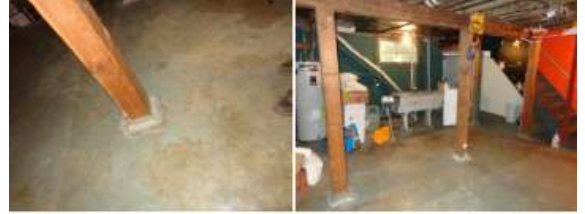
Columns and posts are in serviceable condition
Typical Cracks are noted.

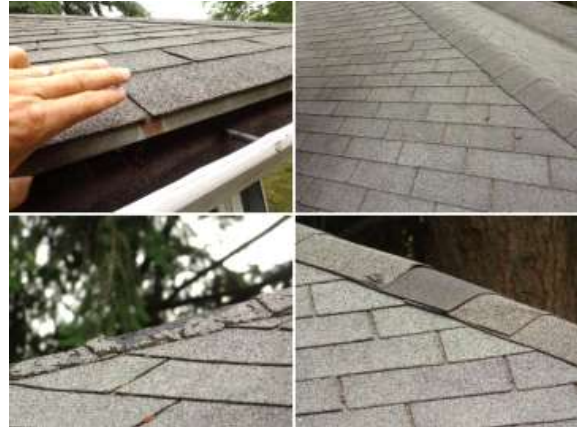
Condition of Roof Covering Material: Advanced age related damage is noted at roof. Further evaluation/repairs or replacement are needed.

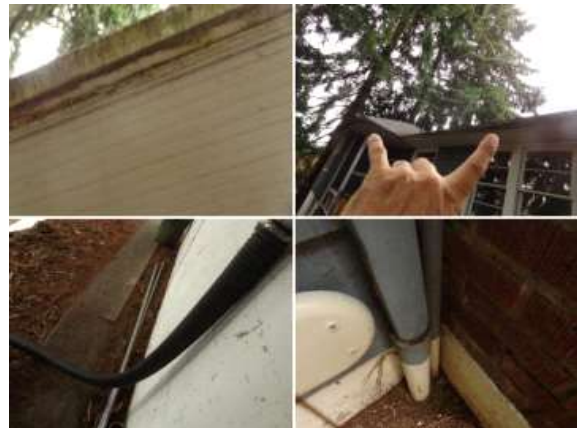
GUTTERS AND DOWNSPOUTS: Full gutters system is installed
 Debris has caused gutters to overflow resulting in damage to fascia. Minor leaks are suspected at joints and corners or downspouts. Gutter tune up may be needed. Monitor and make repairs as needed. Subsurface drains are noted. Subsurface drains are not part of this home inspection. I recommend monitoring the drains for clogging. Suspect improperly draining gutters on west side of building. Monitor and add downspout if

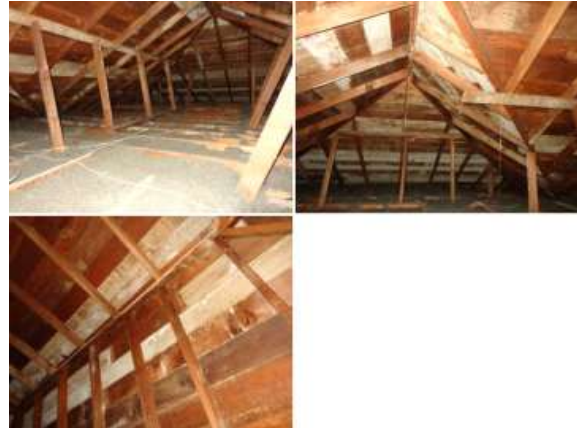
Attic is full size. Conventional Framing. Accessible. Minor dry stains are noted. Improper venting is noted. Soffit vents are obstructed or not installed. Corrections are needed.

Suggest lower smart vents in addition to upper roof vents. Consider installing solar powered mechanical venting.

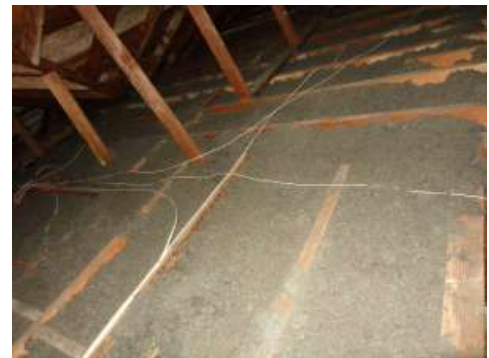
Mineral Wool
Appears serviceable. In Floor
Consider adding insulation.

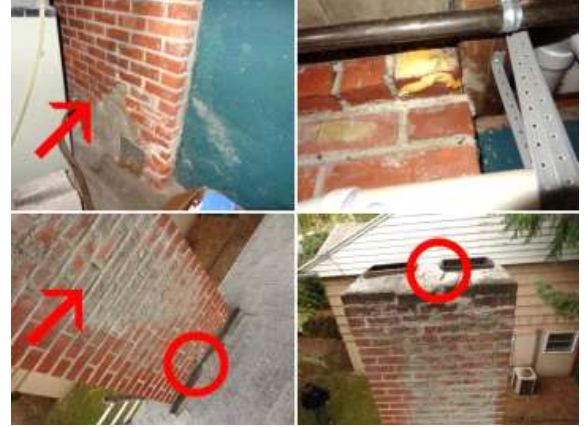
Minor damage is noted at crown. Sloppy repairs are noted at chimney. Recommend contacting chimney contractor for further evaluation and repairs outside as well as at base in basement. Damage there may not be an issue but should be evaluated. Chimney appears to be in need of sealing. Corrections are needed.

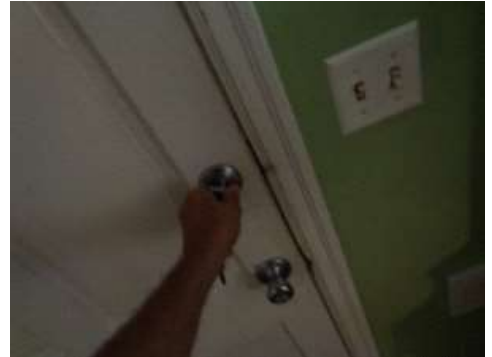
Minor hardware improvements are recommended.

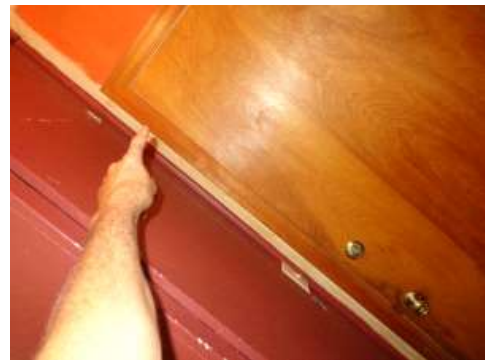
Back door. Rubbing is noted.

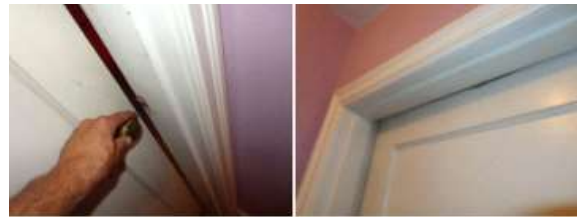
Minor adjustments are recommended.

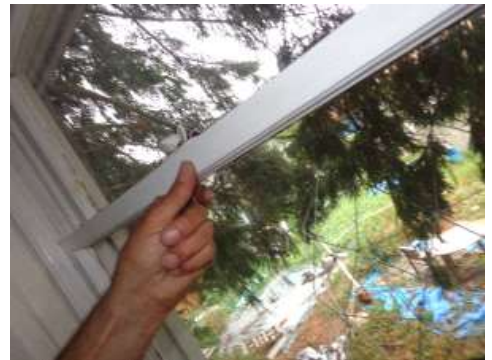
Wood
Windows as a group are generally serviceable.
Windows are painted shut or are difficult to open
Make repairs and adjustments as needed.

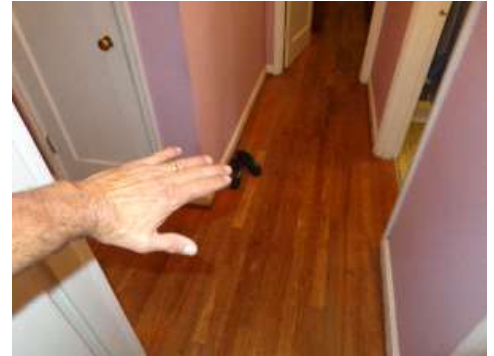
Wood, Vinyl
Appear serviceable
Sloping from settling is noted.

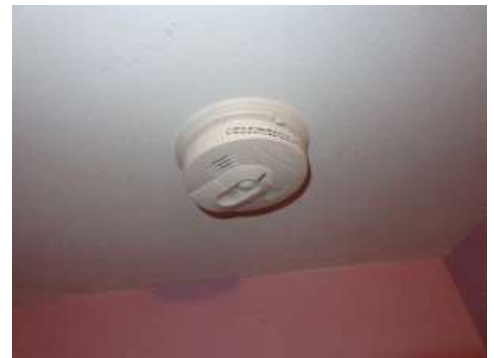
Smoke and Carbon monoxide
detectors are installed and
operational.
Test all detectors monthly
Carbon monoxide detectors
should be installed either on
ceiling (as per Code) or near
floor. (plug in type) Carbon
monoxide is heavier than air
and will collect on floor.
Installing detectors on ceiling
will help if carbon monoxide is
delivered via heating ducts and
air is hot. Eventually it will settle
near floor. Both systems should
be installed for safety.

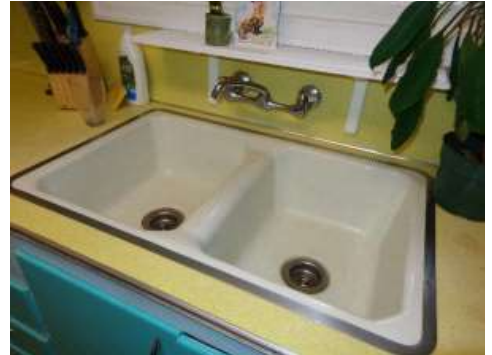
Porcelain
Faucet is operational
Monitor plumbing under sink for signs of leaks.

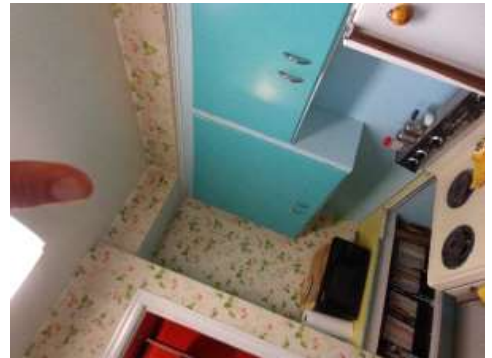
No ventilation is installed. Exterior ventilation is recommended.

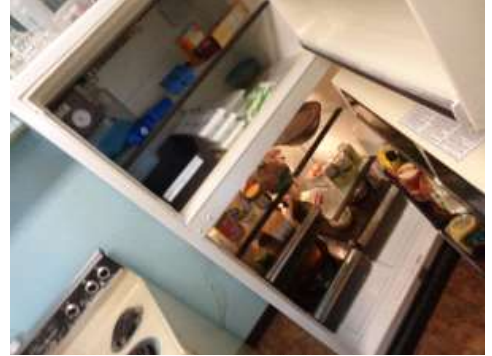
Fridge is older but still operational. If providing water to the system: Recommend monitoring fridge for signs of leaks at water connection.

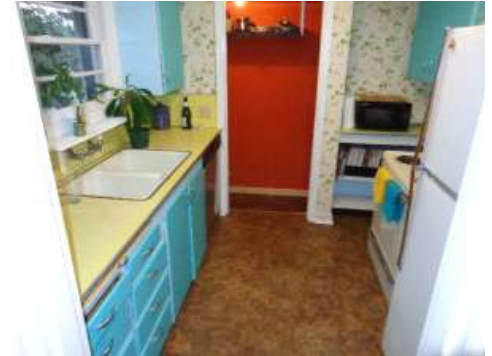
Formica, Counters are serviceable. Wear is noted. Cabinets are in good condition.

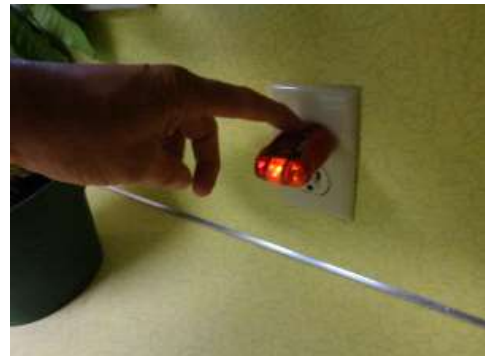
GFCI outlets need to be installed in all locations except at refrigerator.

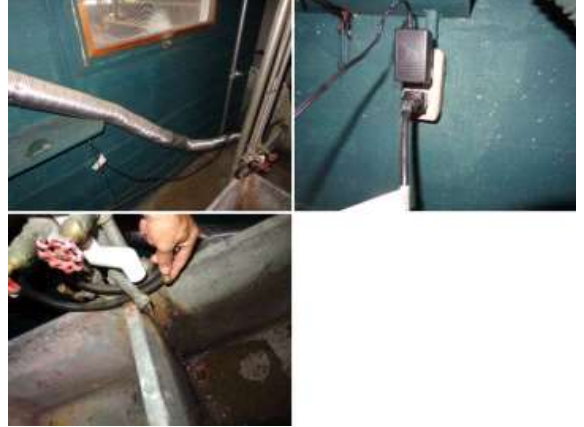
110 is not grounded or GFCI protected. Corrections are highly recommended for safety! 220 is provided. Vent is provided. Recommend installing ridged metal vent for safety. Older style sink is provided. Monitor plumbing for leaks.

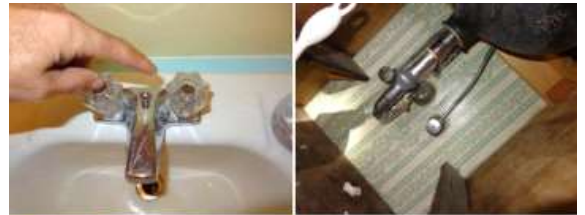
Older sink is installed. Wear is noted. Monitor plumbing for leaks in the future.

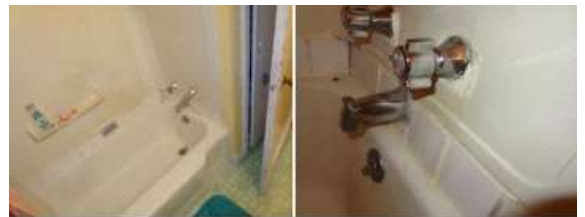
Shower fixtures and tub area including walls and faucets are in need of upgrading. Messy caulking in inferior wall materials are noted. Conducive conditions are present. Repairs and improvements are needed. Ensure new plumbing is properly installed and provide sealer for tile walls if installed. Monitor all caulked areas for damage in the future and make improvement and corrections as needed. Check plumbing for leaks periodically and repair as needed.

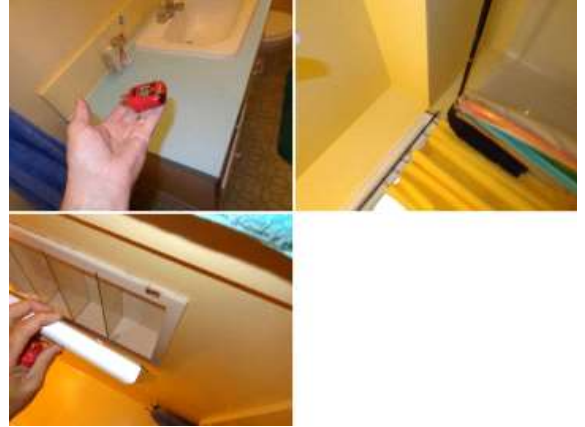
No outlets have been located in bathroom. Consider corrections. A vent is not installed. Consider installing exterior ventilation. Cabinet is noted behind mirror.

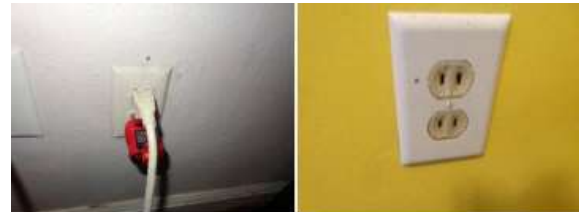
Reversed Polarity is noted and marked with flag or dot to left of outlet
Improperly grounded outlets are noted and are marked with flag or dot centered on outlet
Ground Fault Circuit Interrupter (GFCI) outlets are recommended for installation at exterior, garage, bathrooms and kitchen outlets.
Corrections are needed.
Additional outlets with similar issues are suspected behind furniture.

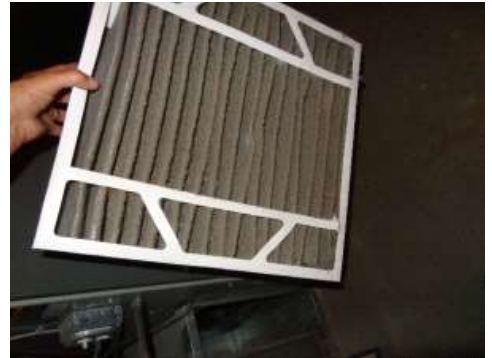
Filter is dirty and needs to be changed
High Efficiency filter will need to be changed every year.

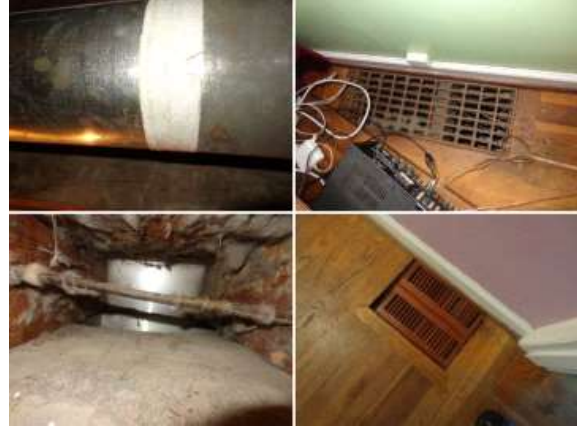
Asbestos tape is noted at ducts, Asbestos tape noted is in good condition, no loose materials are noted. Consider sealing tape by painting or wrapping in new tape to prevent any future deterioration.

Improvements at register in hallway is recommended.

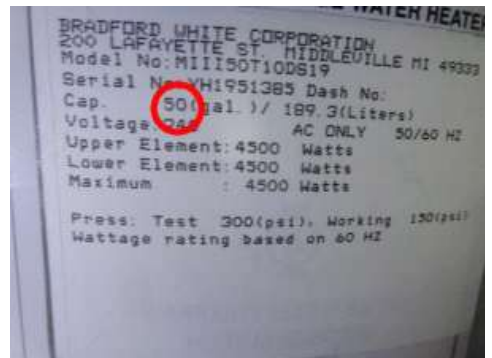
50. Water heater is 19 years old.

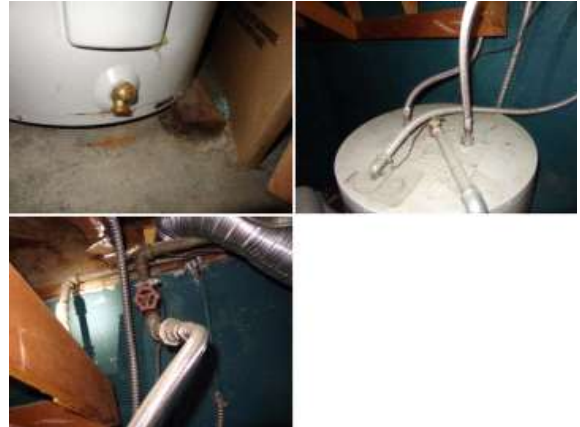
Basement.
Earthquake straps need to be installed
TPR valve is installed and is in serviceable condition. (Tpr valves are not operated since they tend to remain open after operation)
A shut off valve is noted and is in serviceable condition
System has outlived its usefulness but is still operational. Monitor water heater and replace as needed.
We expect water heaters to last about 12 to 15 years. Monitor water heater for damage and leaks or rust and replace when signs of damage are noted.
Ants appear to be nesting inside heater insulation.

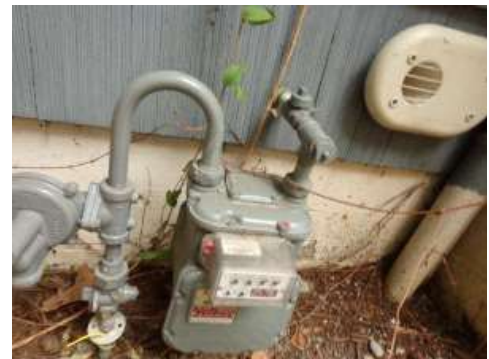
Exterior Location, System appears to be serviceable. Recommend contacting your local Utility, request a gas meter shut off wrench and install the wrench behind meter for emergency.

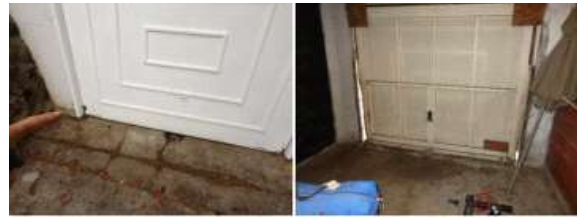
Door needs to be replaced.
