Report: 001442Client416NW13thAveunit411 Address:

Confidential Inspection Report 416 NW 13th Ave Portland OR 97209

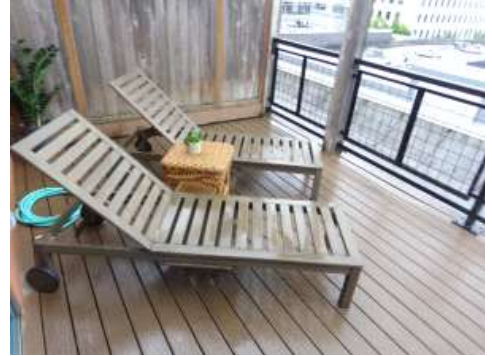
Synthetic materials.

Appears serviceable.

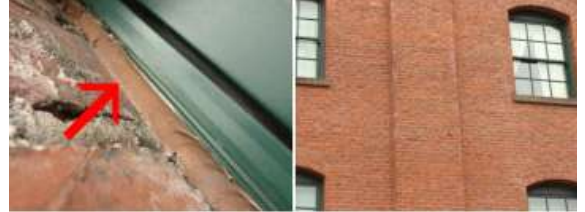
Brick and concrete.

Walls are maintained in good condition. No staining is noted. Brick appears to be well sealed.

Ensure building monitors all joints between different building materials for signs of deterioration.

Brick needs to be sealed and re sealed about every eight years.

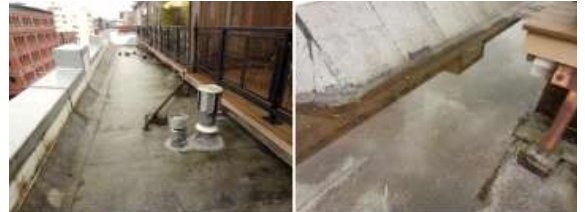
Rolled Composition/built up bitumen type.

This type of roofing material has a very short life expectancy and needs regular ongoing maintenance.

Consideration should be given to replacing rolled roofing/bitumen material with TPO/PVC liner type material in the future.

Ensure new material is installed with proper slope to prevent pooling water.

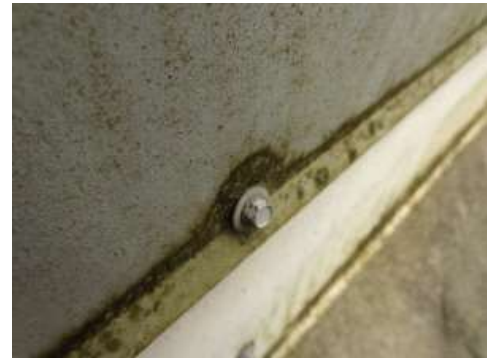
Metal and rubber.

Monitor Caulking at joints and rubber gaskets at fasteners for damage.

Regular inspections of flashing are recommended. Make corrections as needed.

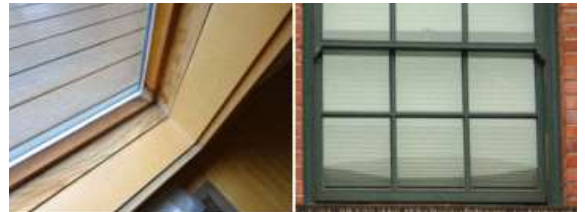
WINDOWS: Type and Condition Wood/metal clad older and newer windows are all operational. Suggest re staining window trim.

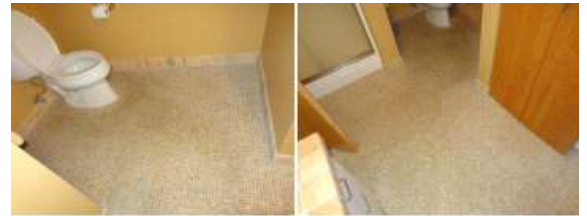
Wood, Tile
Staining is noted in master bathroom. Staining is due to improperly sealed tile floor. Tile should have been sealed after installation to prevent staining from foot traffic and moisture. Recommend consulting tile expert for potential ways to correct the issue.

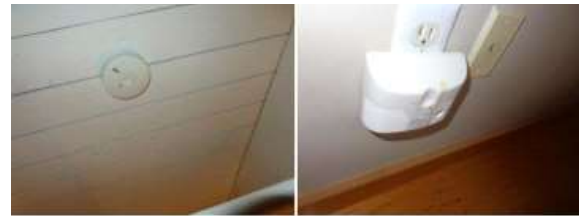
Smoke and Carbon monoxide detectors are installed and operational. Test all detectors monthly

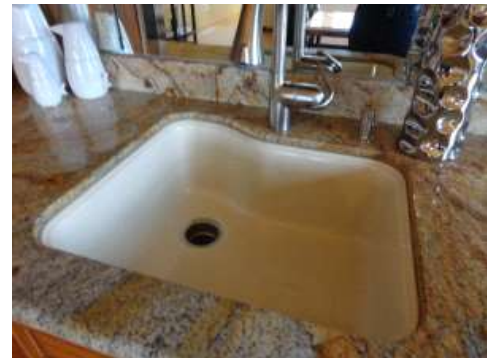
Fiberglass sink is installed.
Faucet is operational
Monitor caulking at under mount sink for deterioration and replace as needed.

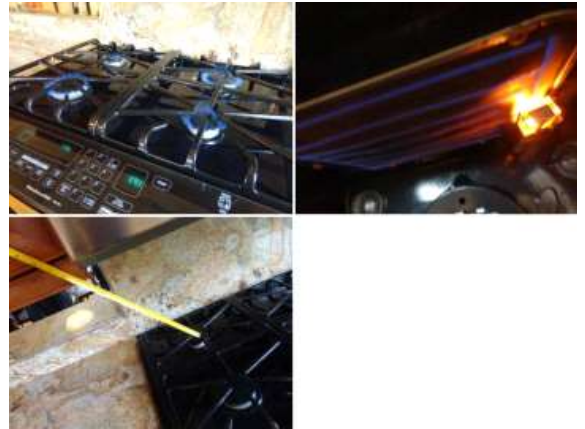
Gas, Free standing
Appears to be serviceable
Oven is operational.
Distance between top of burners to nearest combustible material has to be 16 inches by code. This was not observed at the time of construction. Consider corrections. (safety)

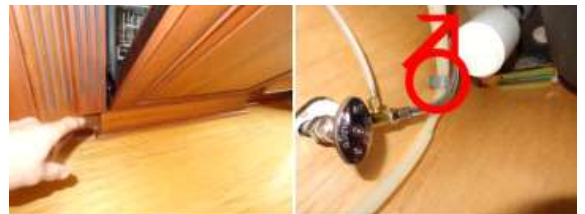
Dishwasher door does not open without getting stuck on trim below.
Improvements to high loop are recommended.
Raise loop by about two to three inches so it is directly under counters
Corrections are recommended.

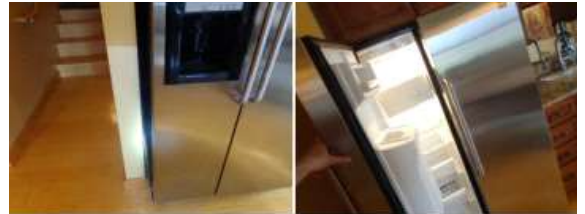
Fridge and Ice maker are serviceable
I recommend installing electronic shut off valve that would prevent flooding should the supply line ever leak.

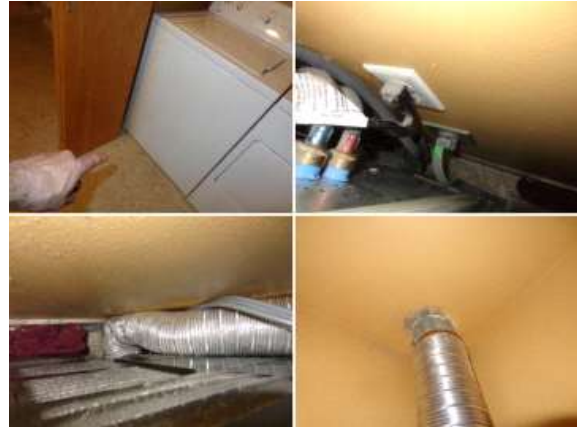
Vent is kinked at base of dryer causing potential fire hazard. Overall length of vent is not posted and can not be determined. Suggest asking HOA about condition of vent runs. Runs can not exceed 25 feet with 90 degree angles counting as 5 feet. Any longer runs need to have a booster vent installed in order to prevent potential fire issues.

Further evaluation is

needed.

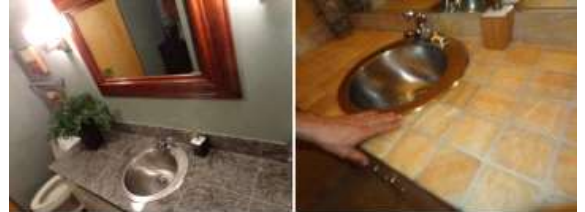
Appears to be serviceable
 Recommend using tile and grout cleaner/sealer on a regular basis to prevent premature deterioration and staining.
 Faucet is operational.
 Drain is serviceable.
 Older leak was note under master sink. Not active.

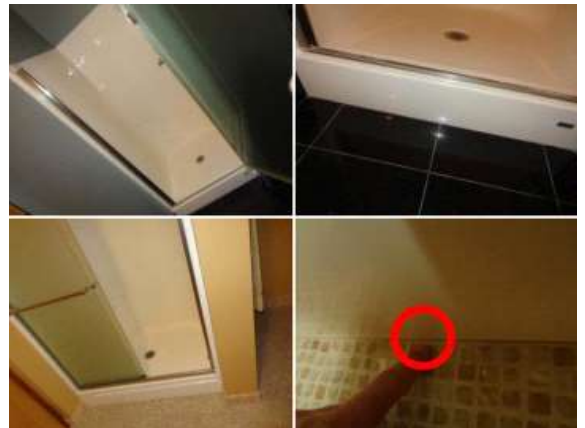
Monitor fiberglass shower pan drain for leaks. Maintain caulking in good condition.
 Improvements are needed at master shower. (Caulking)

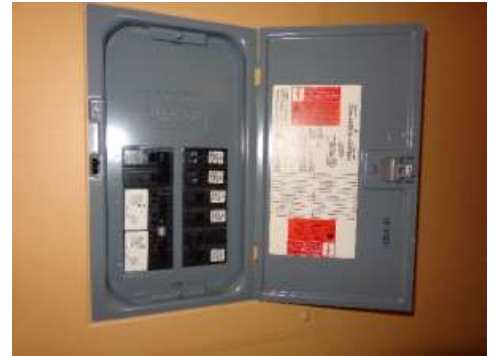
Panel Location and Condition: Amp rating not known. A main breaker is not installed. (Appears to be 125 amp)

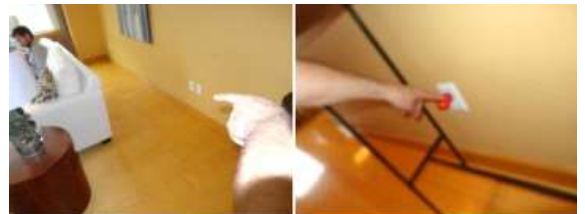
A representative sampling of switches and outlets was tested. As a whole outlets and switches throughout the house are in serviceable condition.

Two loose outlets are noted. One on east wall of living room the other in hallway north wall near corner of living room. Minor corrections are recommended.

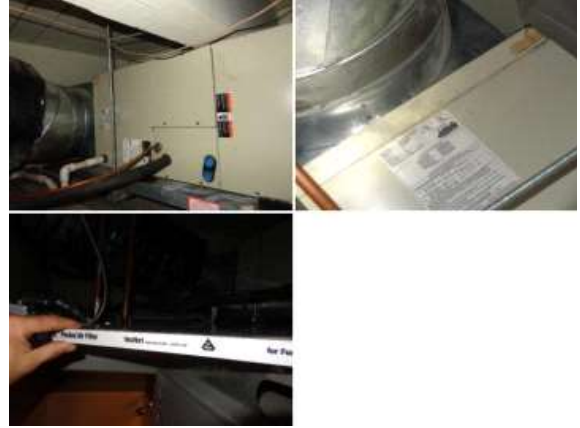
Filter is installed and is serviceable. Filters should be changed every 30 to 45 days, depending on conditions.

Filter access is very difficult to get to. Suggest making improvements to cold air return. Contact HVAC contractor for changed to system so a high efficiency box filter can be installed. High Efficiency filter will need to be changed every year.

Corrections are recommended.

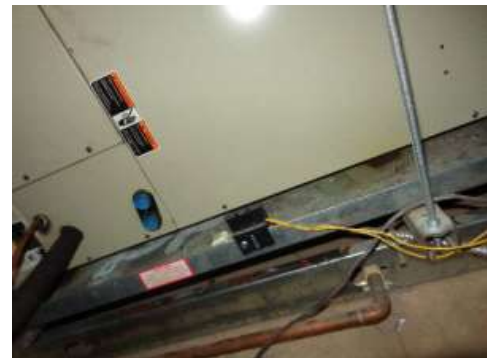
Monitor for sing of leaks from drip pan. Float switch is installed but may fail under stress.

Recommend servicing the heating system annually. Consider starting a service contract with a HVAC contractor. This will insure proper operating conditions.

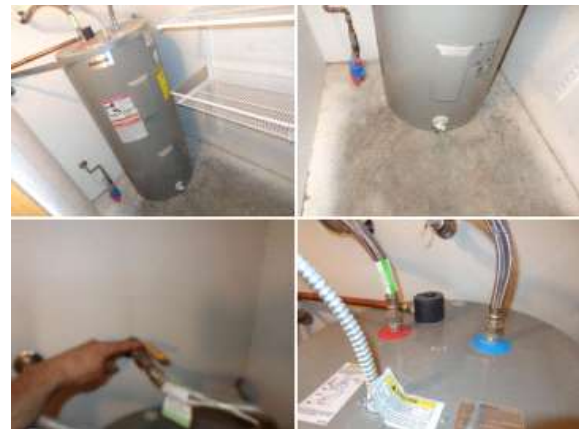
TPR valve is installed and is in serviceable condition. (Tpr valves are not operated since they tend to remain open after operation) A shut off valve is noted and is in serviceable condition Monitor Water Heater. We expect this type of system to last about 12 to 15 years. Look for rust

staining and corrosion at top and at fitting. Monitor heater for minor leaks. Replace unit if damage is noted.

Recommend installing a drain pan under the system. Install plumbing draining, terminating to safe location.
